Lifting of relief valves on cooling circuits.

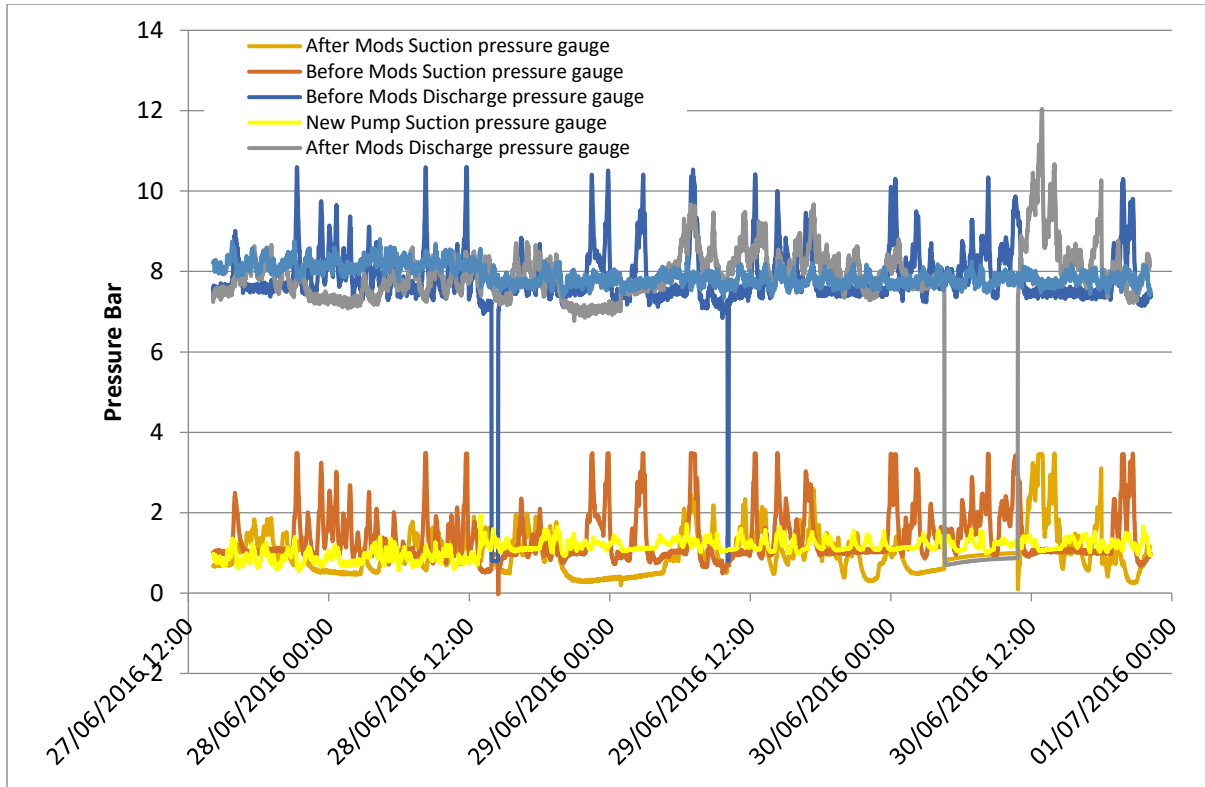
It was agreed that the suction and discharge pressures were measured and recorded over a period of a week for each circuit after the tests were completed and the results analysed the reason for the relief valve lifting was established and this was due to increase in suction pressure over successive heat treatments. The cause of this was due to incorrect installation and management of the pressure vessel. Rectification work was carried out by the client on the system and tests repeated and the results analysed, and it was reported that there had been no further instances of the pressure relief valve lifting. Next ERIKS investigated the reason why the motors were overloading and running hot. When the pumps were first installed, they were controlled via inverters and this limited the maximum speed the pumps could operate and there was also a change in cooling circuits which meant a change of impeller to a larger size.

The chart below shows the suction and discharge pressures before and after pressure vessel modifications and test conducted after the new pumps were installed.

The inverters failed and a decision was made not to replace them as they did not offer any automatic control function. ERIKS supplied four number bare shaft pumps which the client installed onto existing baseplates the replacement pumps were selected to do the required duty and not overload the motors. Installing new pumps, the client potentially saved £40,000.00 on energy costs and motor failures were reduced.
