Case Study - Audit

Pump Stopping due to pulling more amps than the motor rated amps.

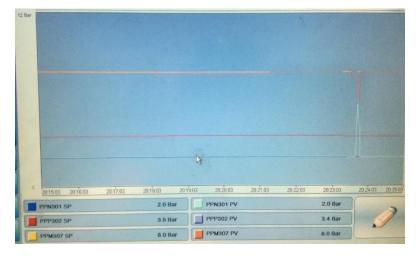
Below is a picture of the control screen showing the drop-in pressure on PPM307 and the increase in pressure on PPN301 this was occurred when the pump tripped

The pump stopping on motor overload was caused when the pressure being developed by the pump (a) supplying increased and the pressure developed by the pump (b) was stopping, decreased indicating that a control valve was slow in re-acting to a change in demand. The slow acting valve was identified and replaced by the client. Removing the pump for overhaul would not have resolved the issue.
